**Water Quality Data Report  
For  
The Silvermine River and Lower Norwalk River  
June 2009 through July 2009**

Water Quality Data Report for  
The Silvermine River and Lower Norwalk River  
June 2009 through July 2009

Water Quality Monitoring of the Silvermine and Norwalk Rivers and Assorted Storm Drain Discharges from June to August 2009.

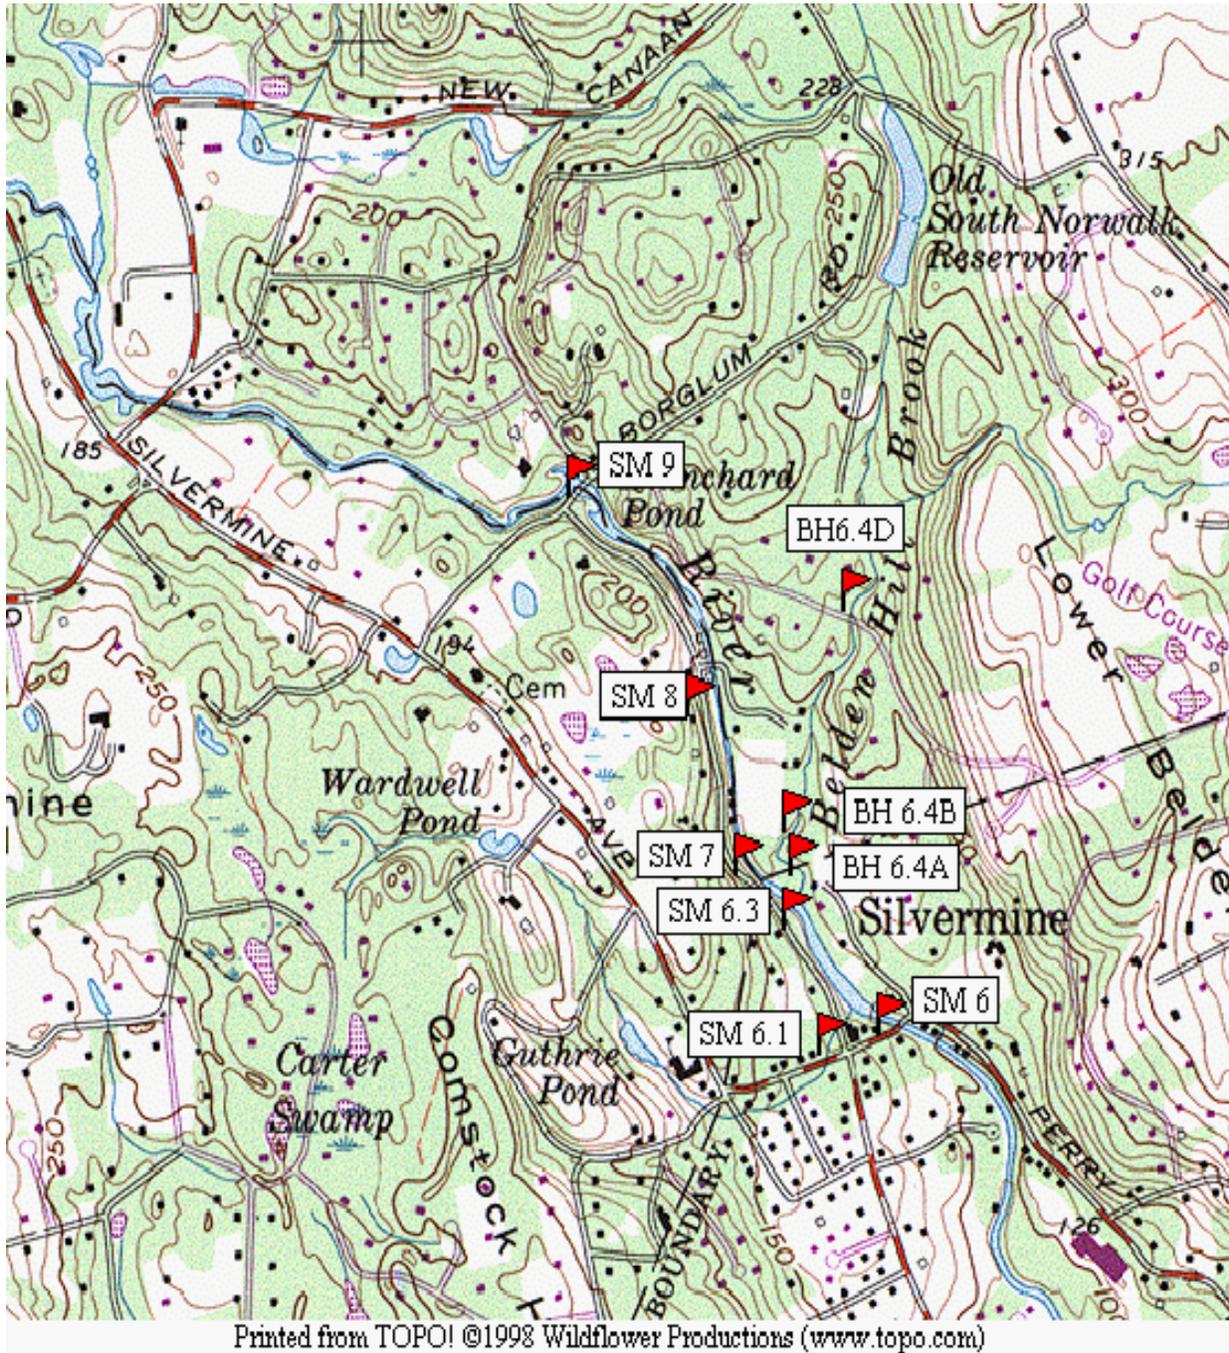
Figure 1 Map of Zone A Silvermine River from Borglum Road south to Perry Avenue Bridge showing monitoring sites on Belden Hill Brook and the Silvermine River

During the summer of 2009, the Norwalk/Silvermine workload was focused on three zones indicated as A, B, and C (Figure 1, Figure 2, Figure 3). The first of these zones, running from Borglum Road to the Silvermine Tavern at Perry Avenue, is referred to as Zone A. This section of the Silvermine River and Belden Hill Brook has been studied over 5 years to monitor the effect of a large hobby farm on water quality. The farm property is poorly located for housing farm animals on a property that is situated between the two water bodies. The Silvermine River and Belden Hill Brook form a confluence at the southern end of the property (Figure 4). Over the years, water quality has slowly improved as farm animals (including two llamas) have been relocated by the owner to other locations. Nevertheless, Belden Hill Brook water still does not meet CT DEP water quality criteria for *E. coli* bacteria. In fairness to the farm's owner, Belden Hill Brook water above the farm is now exceeding the CT DEP bacteria criterion for a Class B river. This new development is masking the actual input from the farm, and now points to additional bacteria sources upstream.

Note: Monitoring Site BH6.4C has been relocated upstream to the Musket Ridge Road Bridge. The new Site is BH6.4D as seen on Figure 1.

An additional site (SM6.1) was established on a small tributary to the Silvermine River, which enters the main stream at the Silvermine Tavern (Figure 1). This stream has been found to carry elevated levels of *E. coli* during the summer of 2009.

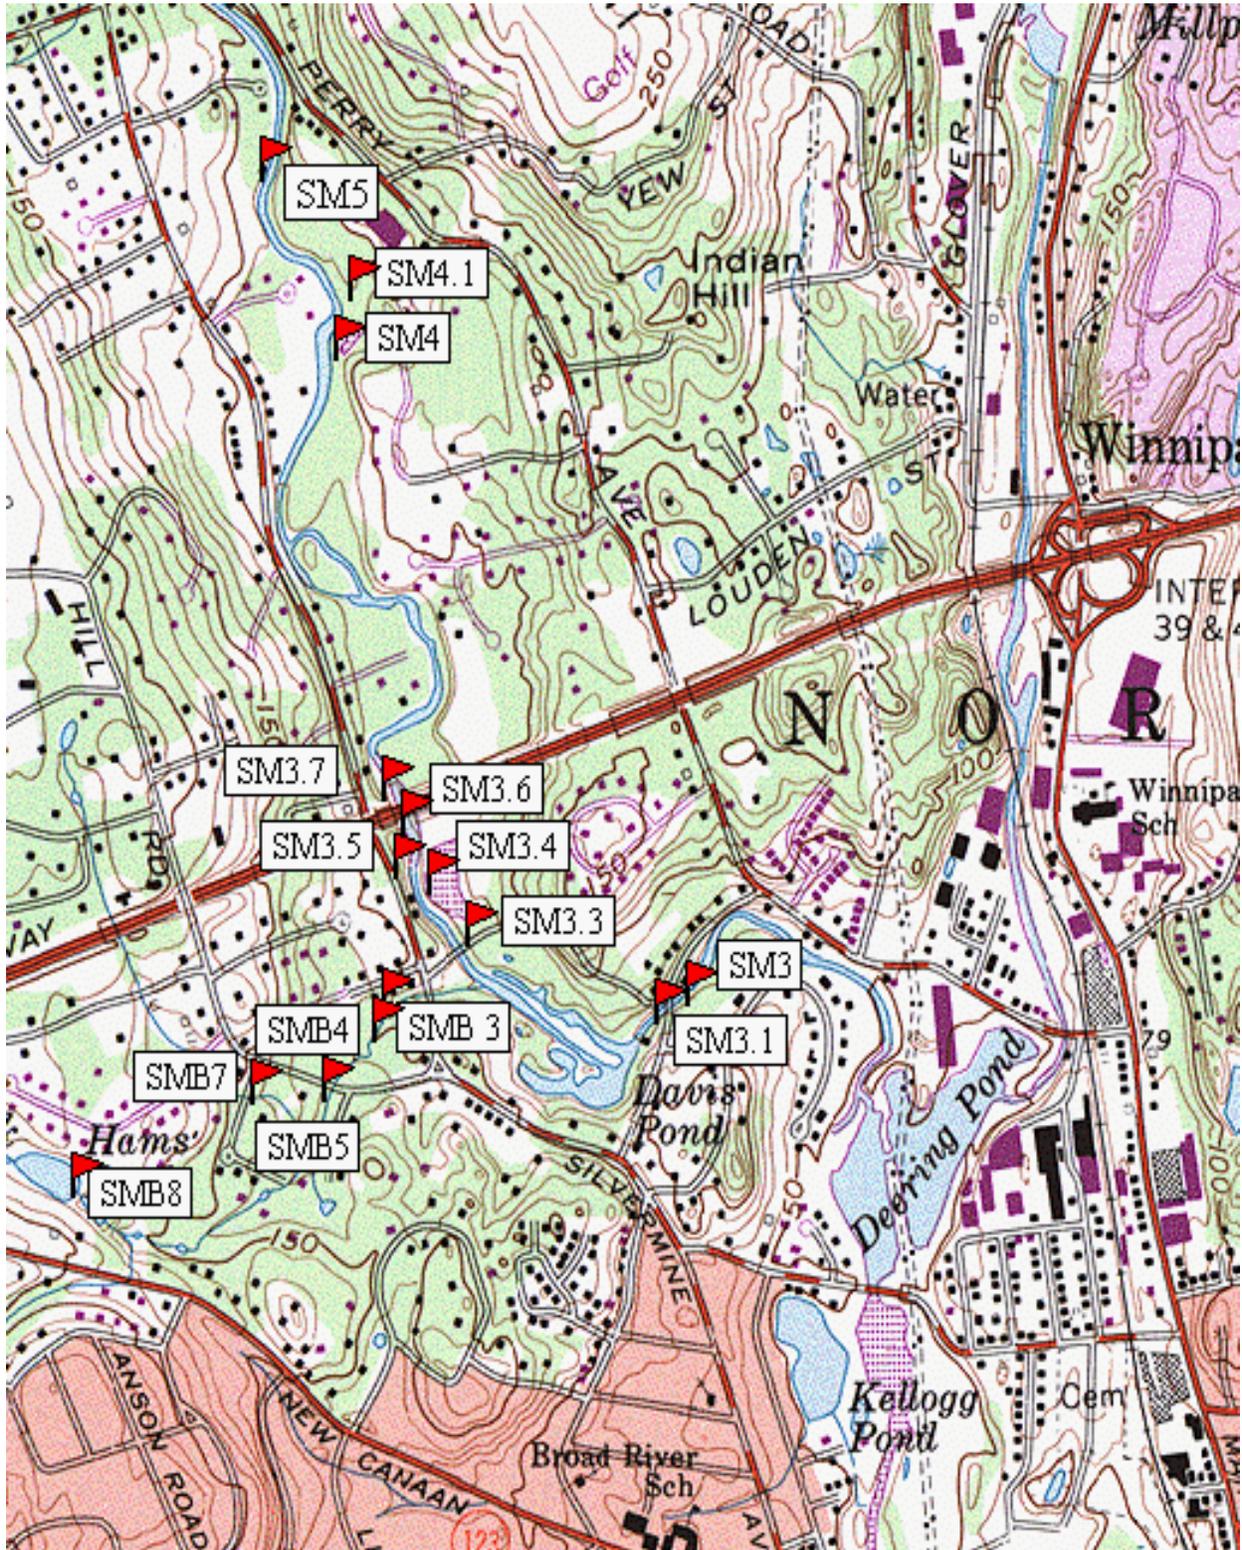
Figure 2 Map of Zone B Silvermine River from the Silvermine School to James Street showing monitoring sites on the Silvermine Brook and the Silvermine River

Zone B is located in the lower portion of the Silvermine River from Perry Street south to Deering Pond (Figure 2). Zone B was first explored in detail by the 2008 Norwalk Mayors Water Quality Committee interns because of elevated *E. coli* bacteria counts found at Site SM3. The 2008 interns were aggressive in exploring this section of the river and new areas were opened up for monitoring including Silvermine Brook (Figure 2). In addition, new sites were established in the slower moving ponds that characterize the Silvermine River in that section south of the Merritt Parkway Bridge downstream (south) to James Street (Figure 2). The owner of the house at 38 Silvermine Avenue allowed the 2008 interns to keep a canoe on his property, and the offer for site access was renewed in 2009. This is the only practical method for reaching the lower Silvermine River monitoring sites. As in 2008, both the lower Silvermine River and Silvermine Brook were found to be moderately polluted with *E. coli* bacteria. A major source of bacteria and nutrient input was confirmed at Site SM3.1 (Figure 2). Septic infiltration is suspected here and the source should be found and corrected.

The lower end of Silvermine River widens into a series of ponds and backwaters as the waterway approaches its confluence with the Norwalk River in Deering Pond (Figure 2). Stream flow is reduced as the river enters the ponds and the water deepens. This condition results in the deposition of fine silt from land erosion upstream (up to several feet in some of the slow moving areas) and the loss of hard river bottom in many places. This area of the river is best explored by canoe as was done again the summer of 2009. There is little change in pollution input since the summer of 2008.

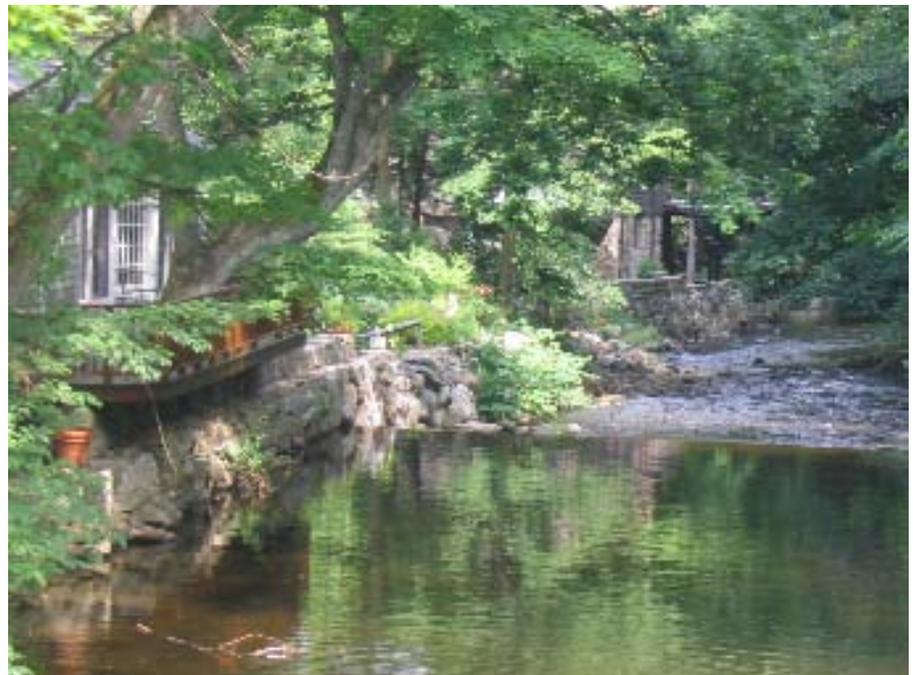
Often development of residential homes occurs too close to the Silvermine River, which frequently eliminates valuable riparian areas. This practice may lead to a major negative impact to the health and water quality conditions of the river.

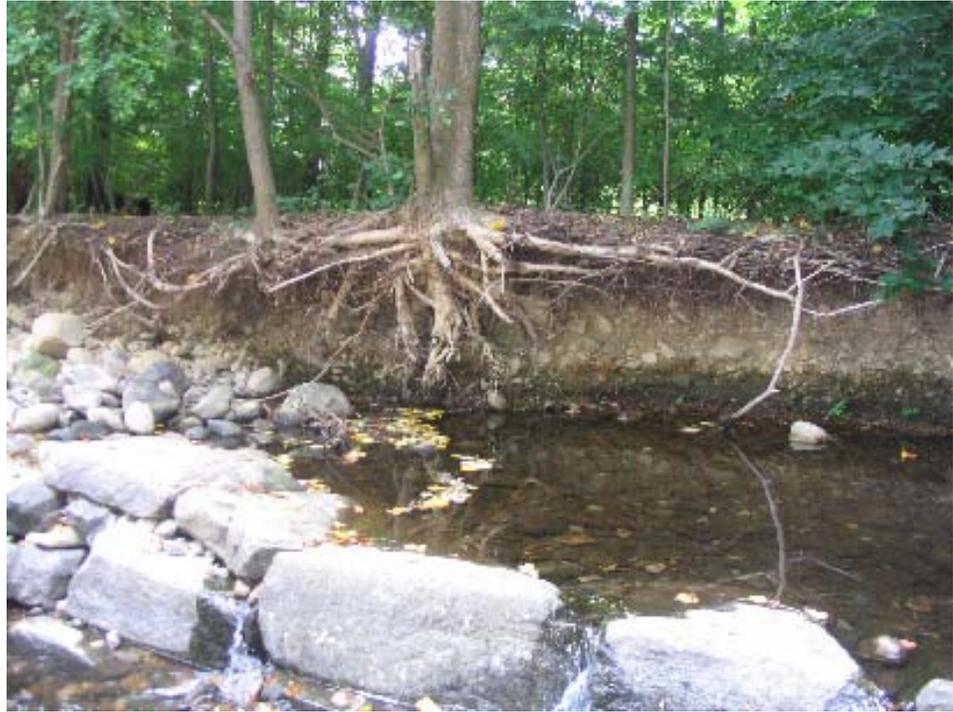
Tree roots have been exposed as visible evidence of stream bank erosion near the Silvermine School site

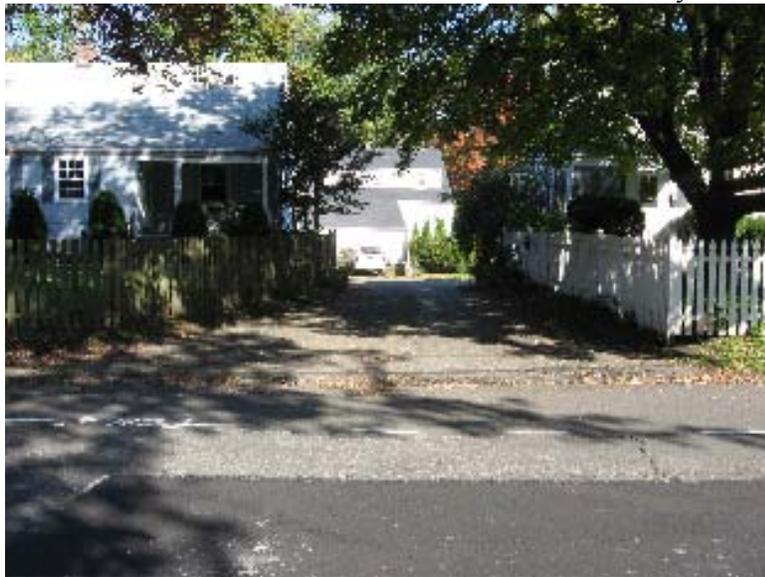
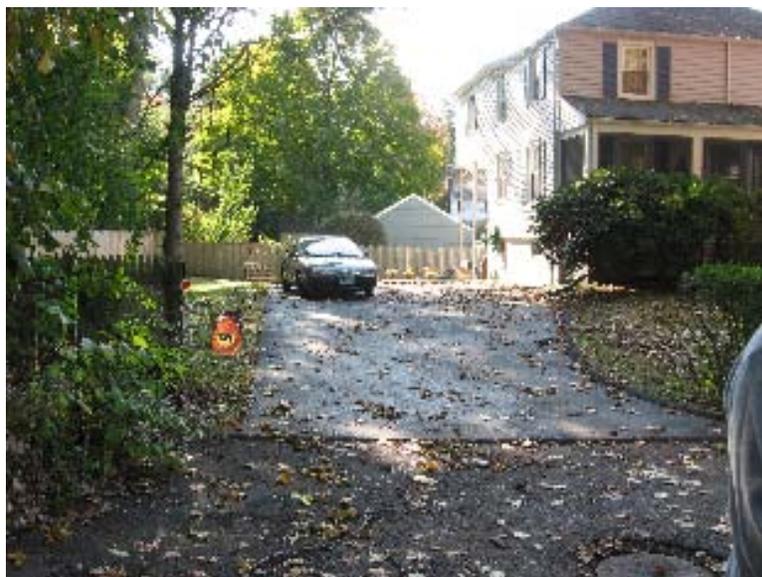
Wastewater from residential properties on Lockwood Lane/Buckingham Place, part of the Moody's Lane Storm Drain System

1. Dye testing of 34 and 38 Buckingham Place, as well as 29 and 31 Lockwood Lane in Norwalk. In the months to come HW/RW hopes to make inroads on some of the other polluting storm drain networks (Figure 17), which have been found to discharge excessive amounts of bacteria to Norwalk Harbor on a routine basis using some of the Techniques used on Moody's Lane (Figure 16).
