**Water Quality Data Report
For
NR13 Watershed
September 2011 through March 2012**

Richard Harris, Principal Investigator, Staff Scientist/Director of the Harbor Watch Program at Earthplace, Westport, CT, Phone (203) 227-7253

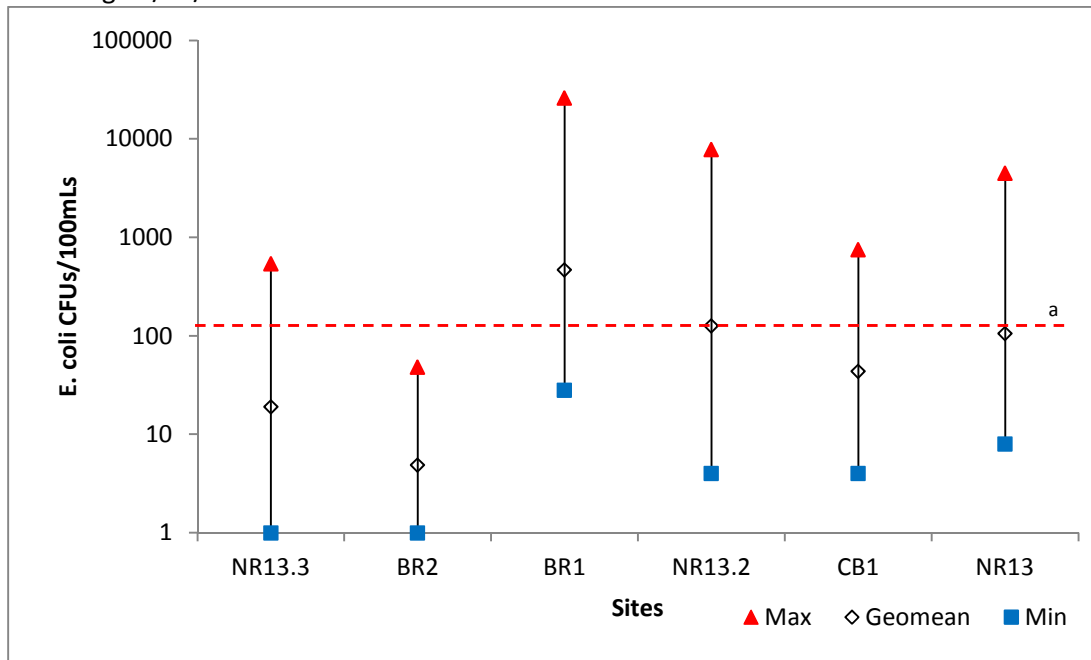
Figure 2 Maximum, geomean, and minimum *E. coli* values for six sites in the NR13 watershed from 9/28/11 through 3/21/12

Results: Observed *E. coli* geomeans at two of the six monitoring sites exceeded the CT DEEP criterion for a class B river of <126CFUs/100mLs (Figure 2). Four of the six sites exceeded the CT DEEP single sample maximum (SSM) of <10% over 576 CFU/100mL for a Class B river (Table 2).

^a CT DEEP geomean maximum for a Class B river

A second site, BR2, was added to the monitoring regime on 11/18/11 to segment Branchville Brook (Figure 1). Over the ten testing days between November and March, not once did BR2 have observed counts exceeding 48 CFUs (Table 2, Figure 2). On 12/14, the team decided to intensively break down Branchville Brook into sections in order to pinch off possible areas of pollution input. Three additional sites were added to the already established BR1 and BR2 on Branchville Brook. These temporary sites were strategically added at points just below a home on the river bank (site C) and at two drainage pipes

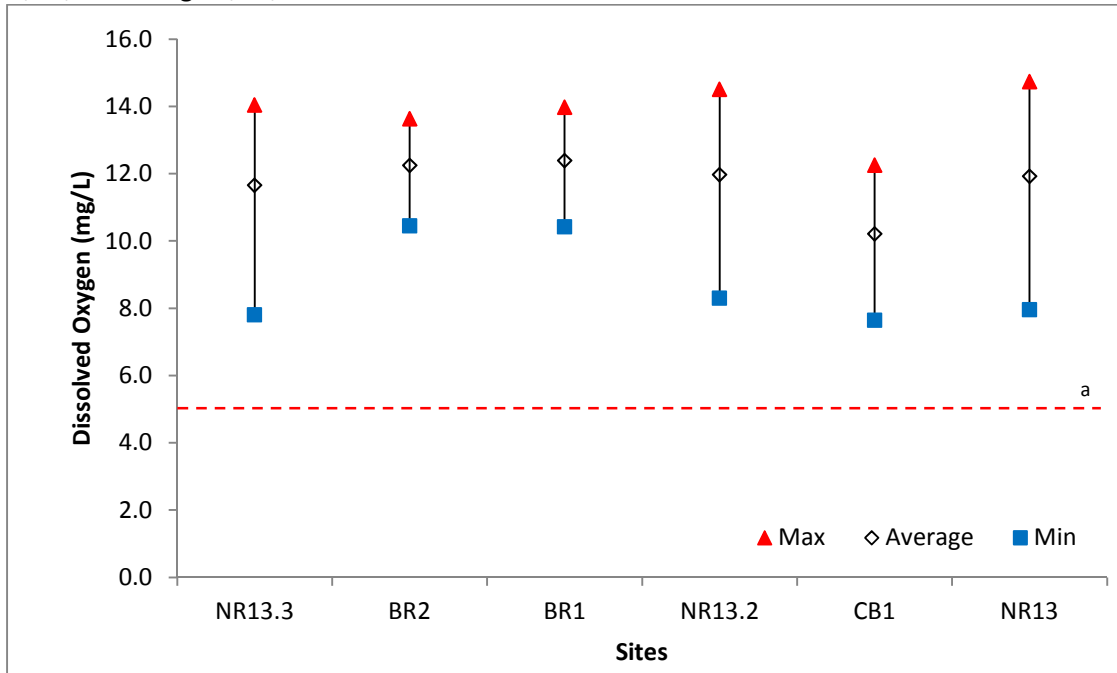
Figure 3 Maximum, average, and minimum dissolved oxygen values for six sites in the NR13 watershed from 9/28/11 through 3/21/12

All observed dissolved oxygen means met the CT DEEP minimum criterion of 5mg/L for a class B river. All individual readings met the criterion as well (Figure 3).

^a CT DEEP minimum criterion for dissolved oxygen for Class B river

Dissolved oxygen means and all individual readings met the CT DEEP minimum criterion of 5mg/L on each sampling day (Figure 3). Even with limited rainfall during the monitoring period, the Norwalk River, Cooper Brook, and Branchville Brook continued to have a constant strong flow. Branchville Brook in particular has a very steep rise which enables the strong flow to be continuous even in times of low rainfall.

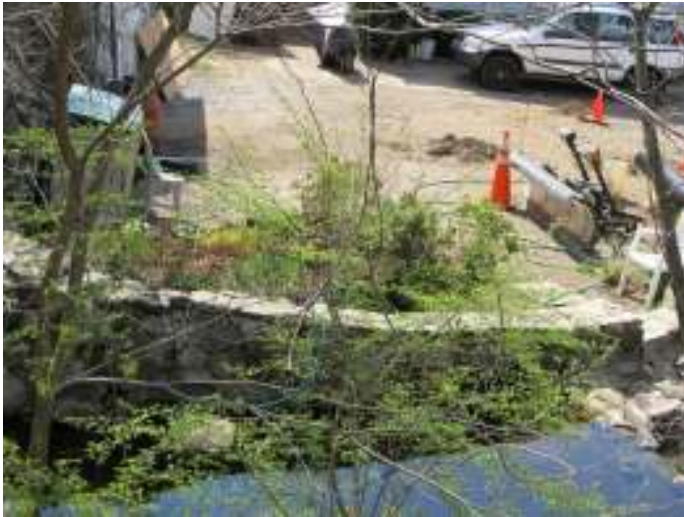
Suspected percolation test for replacing the cesspool at house number 64. Photo taken on 4/10/12.

The town of Ridgefield has ordered both homes to put in septic systems, effective immediately. Until remediation efforts are completed, it is unknown as to whether the cesspool at house number 64 located on the riverbank, the pipe emptying into the storm drain at number 58, and the discharge of marble dust are the only pollution sources. Summer 2012 research efforts will continue to monitor the Norwalk River on a weekly basis which should indicate if the search for pollution in that area has been completed or if further investigation is needed. Harbor Watch, Ridgefield Health Department, and the

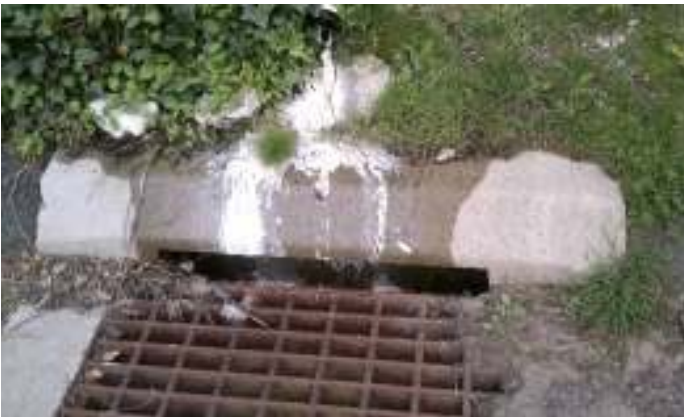
Pipe connected to 58 W Branchville Rd that drains into the storm drain. Photo taken on 5/7/12.

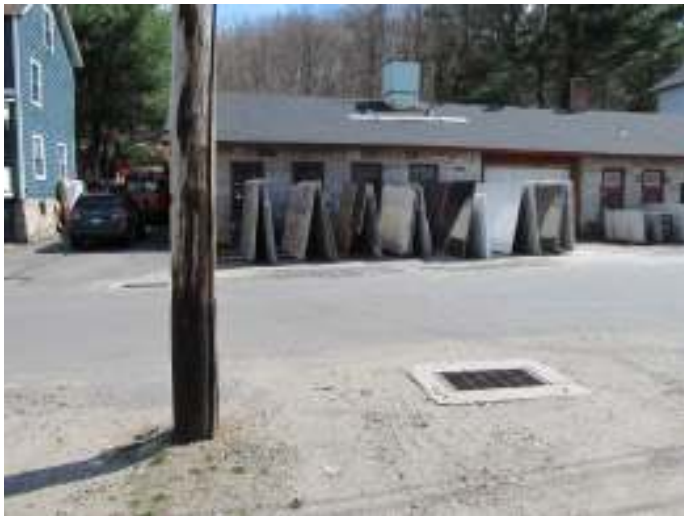
Marble Company and its proximity to storm drain system. Photo taken on 4/10/12.

Conclusion: On January 9, 2012, Harbor Watch contacted Amy Pardee, M.A., Inland Wetlands Agent, at the Ridgefield Inland Wetlands Board to inform her of the data that had been collected and the conclusions that could be drawn. Aimee Pardee further investigated the area on January 11, 2012 and spoke to a tenant living in house 64 W Branchville Rd who admitted to seeing “material oozing” into the river on days of low water which suggests that the cesspool might be failing (Appendix B). A memorandum was issued to the Ridgefield Health Director to work with the owner to eliminate this source of pollution to the Norwalk River (Appendix B). A few weeks later, Ms. Pardee returned to the area to see if any corrections had been made to the cesspool. Along with finding no advancements on remediation, Ms. Pardee noticed another home (58 W Branchville Rd) had a pipe leading from the house discharging directly above a storm drain (Appendix A). After talking to the tenant of house #58, she discovered that the pipe leaks often when using appliances in the home. She also noticed that the Venezia Custom Marble and Granite workshop was allowing marble dust to enter the river through the storm drains (Appendix A). The workers would not make any comments when spoken to by Ms. Pardee. House #58 and the Venezia Custom Marble and Granite workshop are attached buildings. Chris Gerke, Environmental Analyst II Permitting Enforcement and Remediation Division for the CT DEEP, was notified of this and subsequently made an inspection of the premises. Venezia is now under CT DEEP orders to filter the marble dust from the waste water.
